15. Supplementary Notes			
16. Abstract  About 11:06 p.m. on June 5, 1975, a Reading Company commuter train struck a tractor-semitrailer (truck) at a grade crossing near Yardley, Pennsylvania. The truck was transporting three coils of steel, two of which penetrated the first commuter car. The three occupants of the lead car were killed and an occupant of the second car was injured slightly. The truckdriver was uninjured. The semitrailer was torn from the tractor and damaged beyond repair and the lead commuter car was damaged extensively.  At the time of the collision, the automatic grade crossing signal system was functioning. The truckdriver said he had not seen or heard the warning signals.  The National Transportation Safety Board determines that the probable cause of the accident was the failure of the truckdriver to stop the truck in accordance with the warning signals.

About 11:06 p.m. on June 5, 1975, a Reading Company commuter train struck a tractor-semitrailer (truck) at a grade crossing near Yardley, Pennsylvania. The truck was transporting three coils of steel, two of which penetrated the first commuter car. The three occupants of the lead car were killed and an occupan

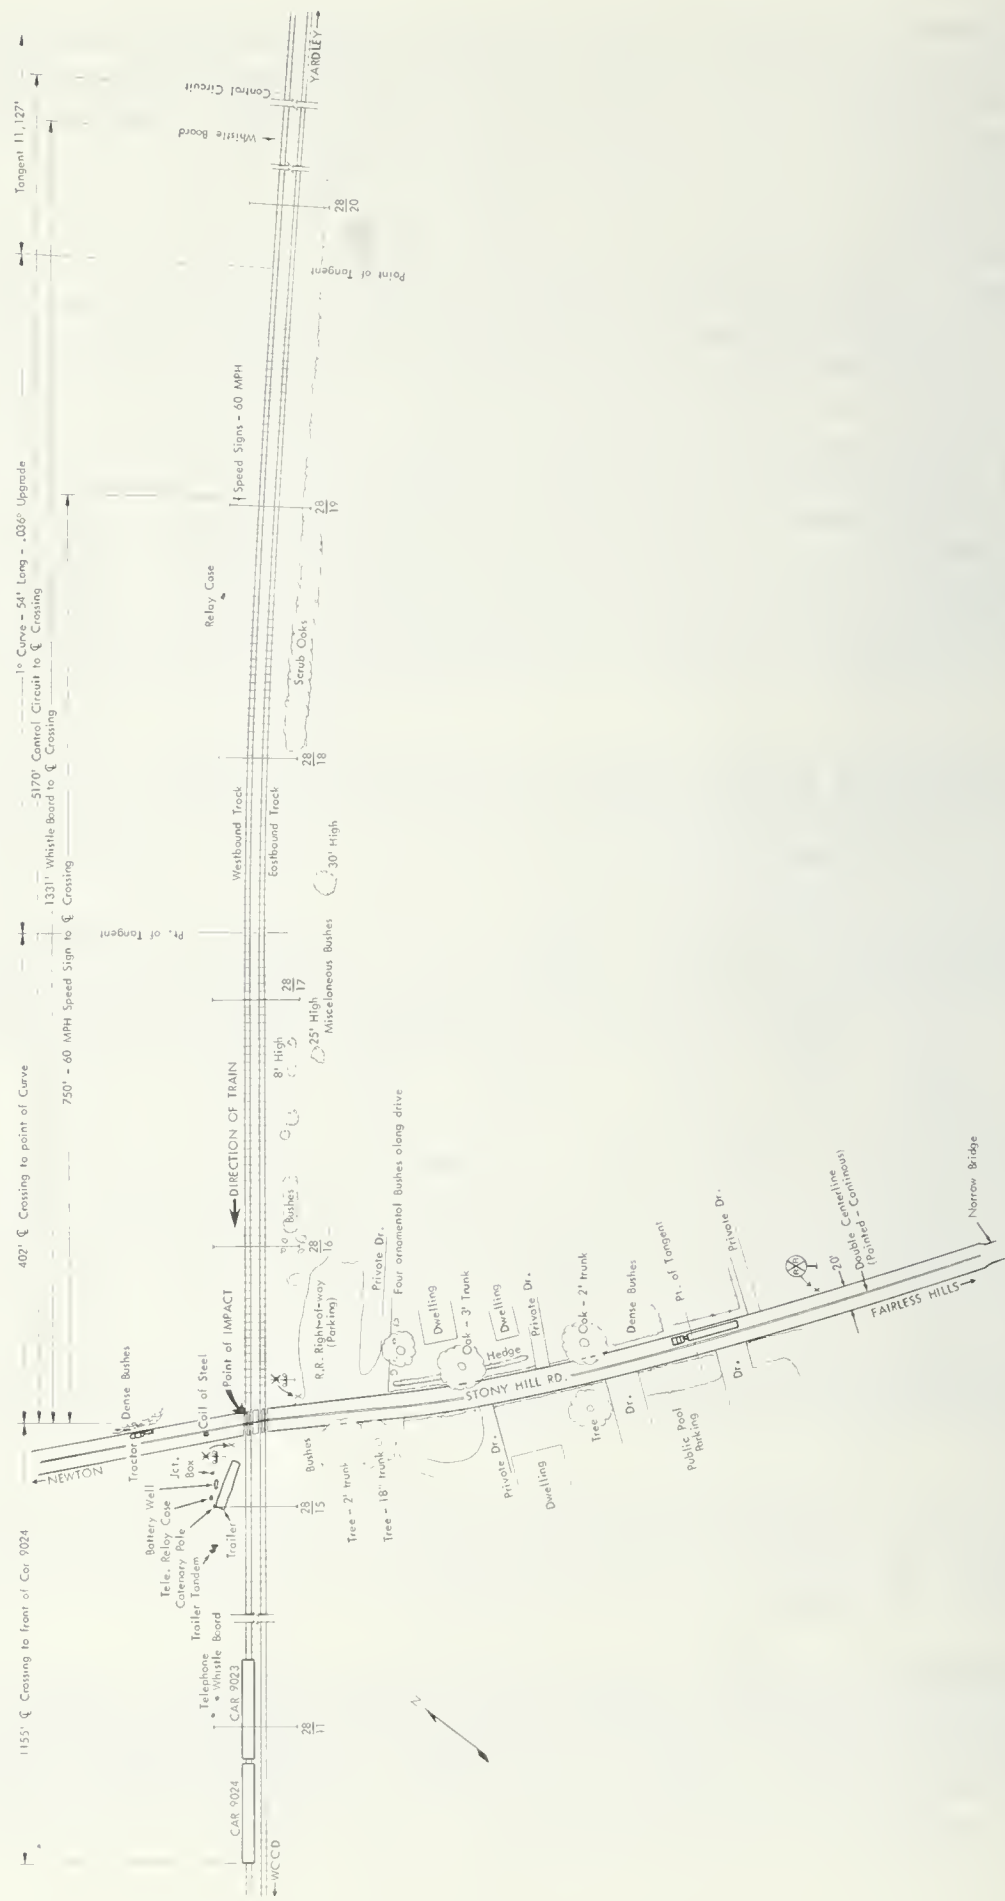
Figure 1. Plan of Stony Hill rail/highway grade crossing.

A sign to give motorists advance warning of the railroad crossing is located on the right side of the roadway, about 460 feet south of the crossing. The sign is obscured partially to motorists approaching from the south by bushes and tree branches.

The automatic railroad flasher signal and crossbuck, located on the left side of Stony Hill Road, are visible to motorists approaching from the south about 500 feet from the crossing. The automatic flasher and crossbuck, located on the right side of the crossing, are visible from the south about 300 feet from the crossing.

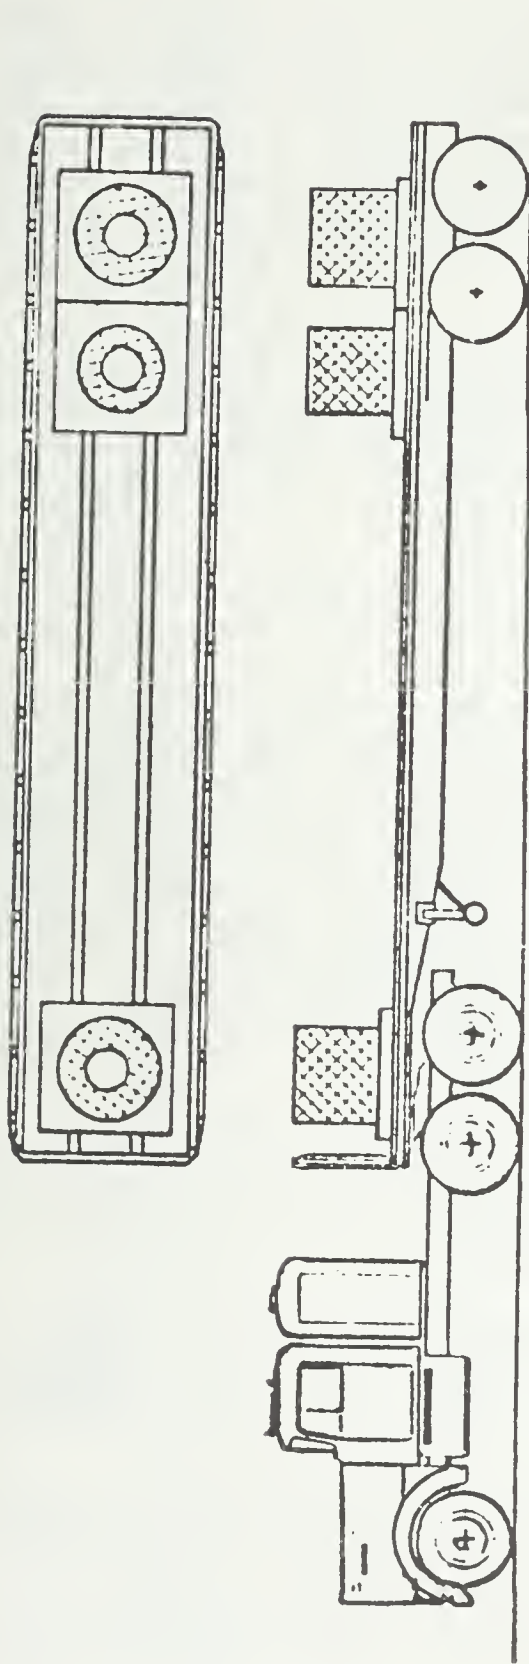
Figure 3. Plan view and profile of truck and cargo, representing typical loading method.

The Train -- The 8-ton coil of steel on the rear of the trailer struck the left front collision post of the lead car 38 inches above the

car floor, shearing the post at its base. The coil entered the front of the car, passed through the control vestibule, dislodged the front passenger compartment bulkhead, and entered the passenger compartment, damaging seats along the front left side of the car. Across the aisle, it dislodged seats and deformed the car wall along the front right side of the car. It struck the center vestibule partition, collapsed it upon the trainman and passenger, and continued into the rear passenger compartment, where it came to rest in the 22nd row of seats, 66 feet from the front of the car.

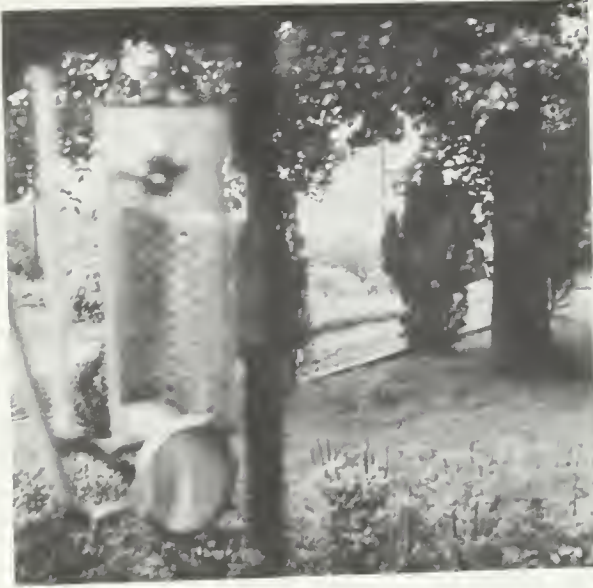
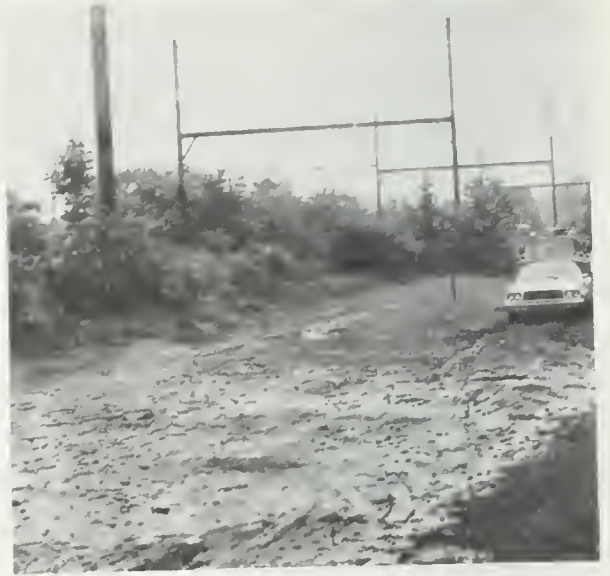
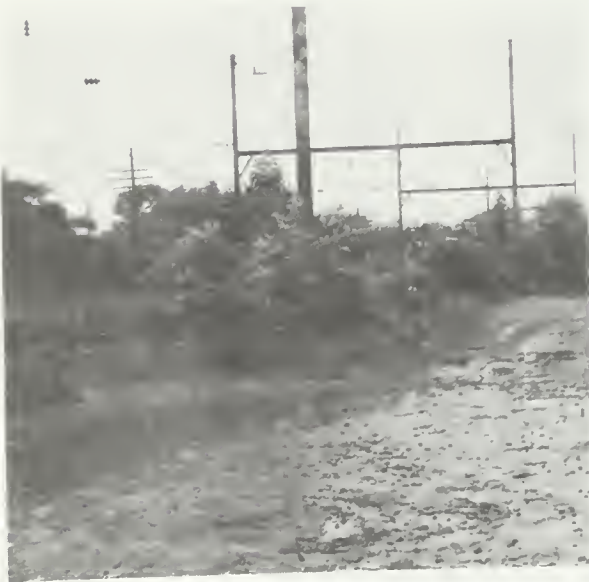
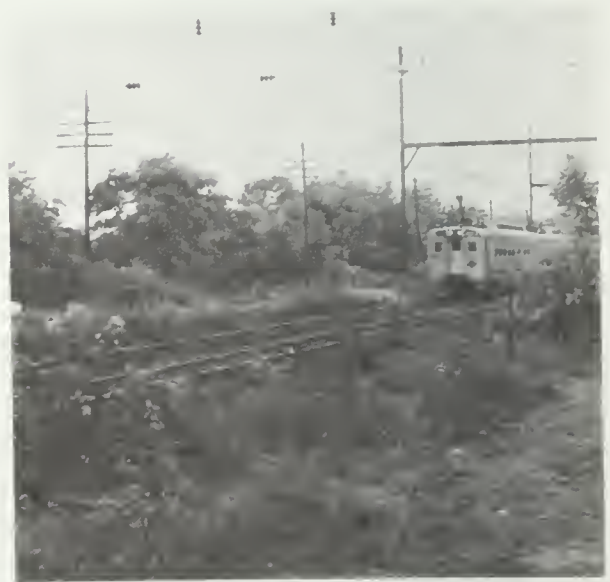
Figure 8. Driver's view of approaching train at selected intervals.

The driver had used this route frequently. Although he may have had an illusion of good track visibility to the east, the vegetation along the right-of-way intermittently obscured the driver's view until the truck was near the track. The vehicle speeds, the darkness, and the adverse weather could have accounted for the driver's failure to see a train approaching from the east.

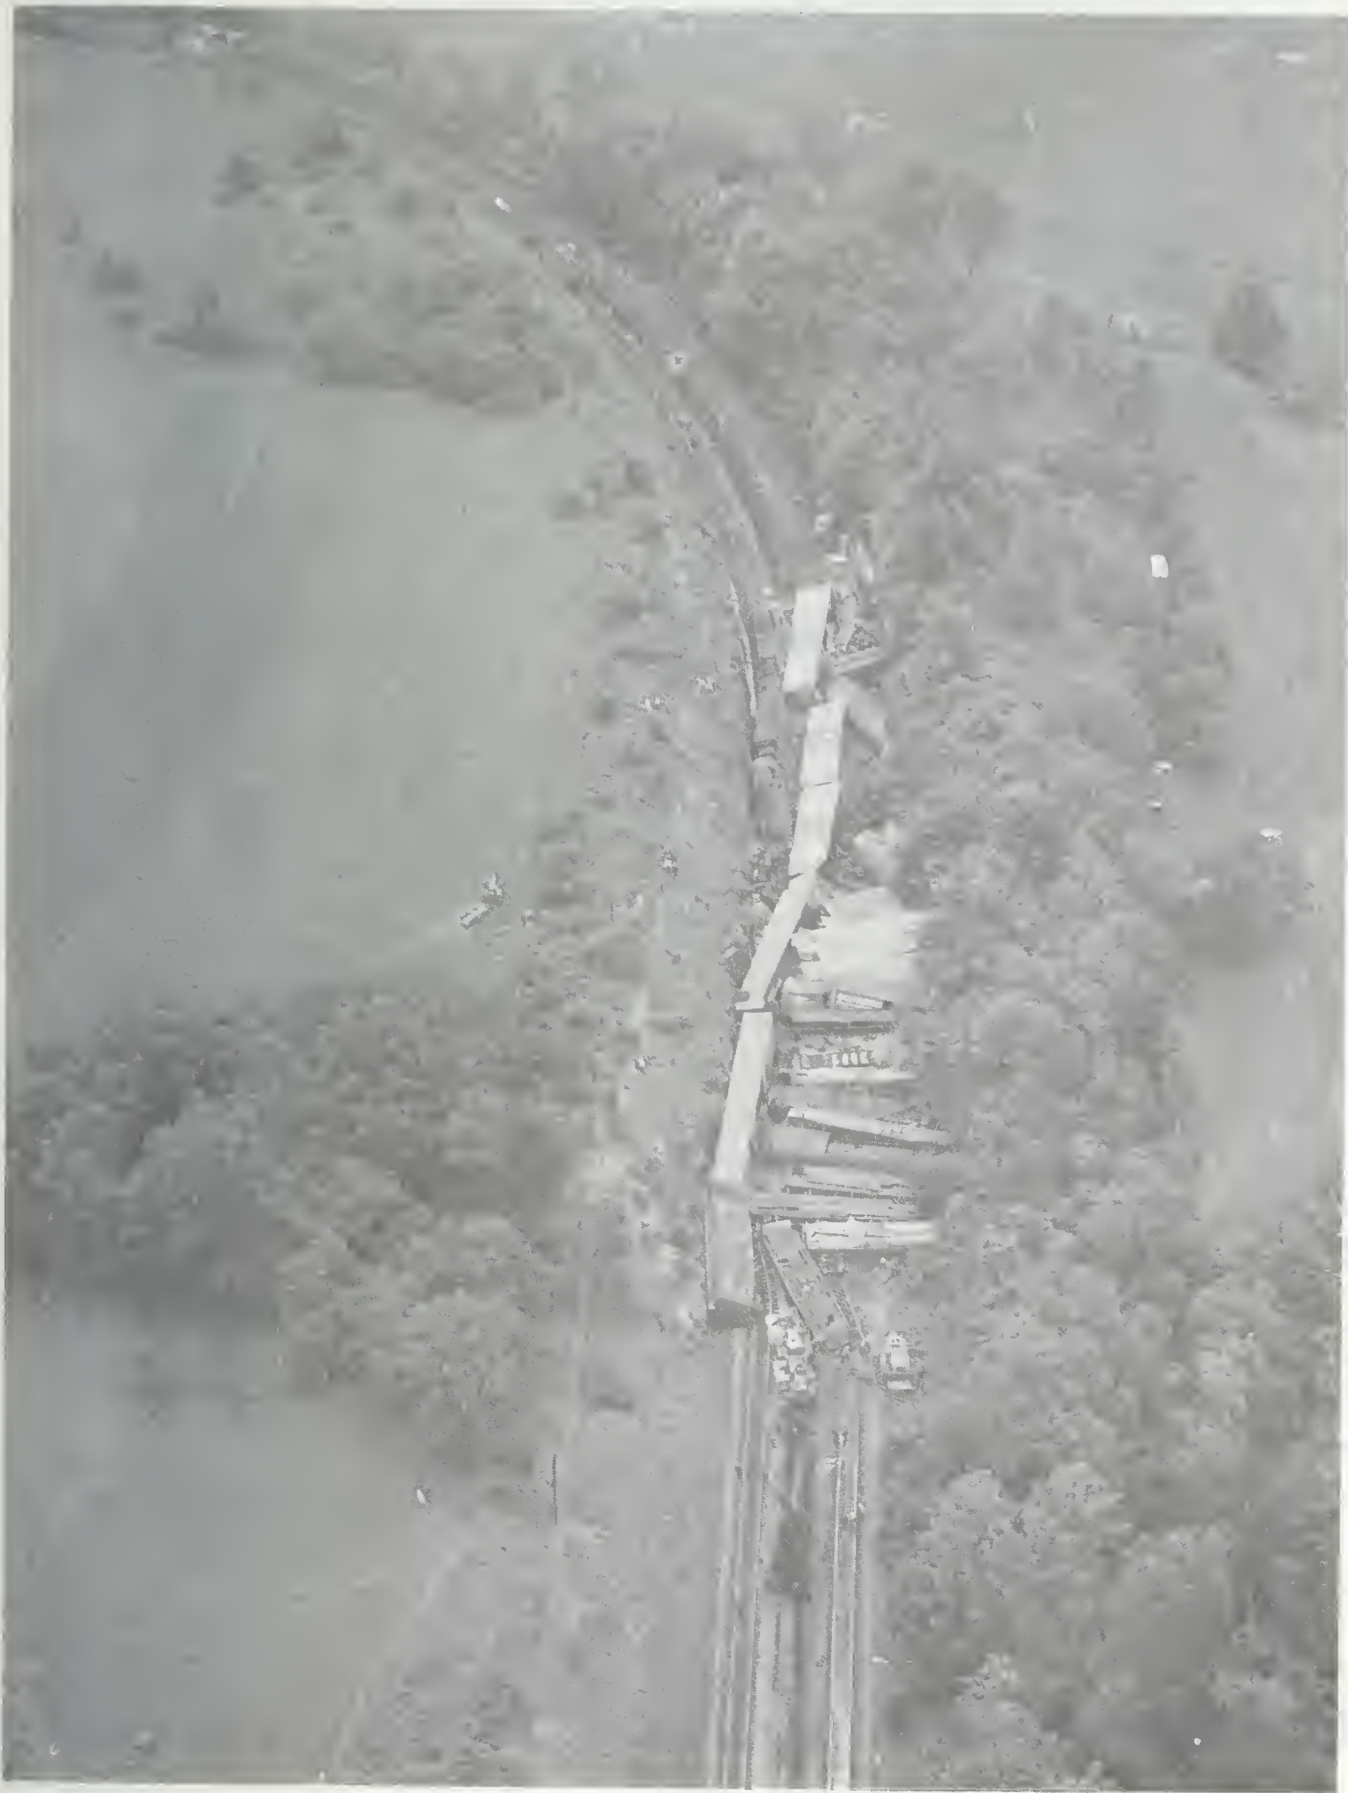
Figure 2. View of the accident site as seen from the west.

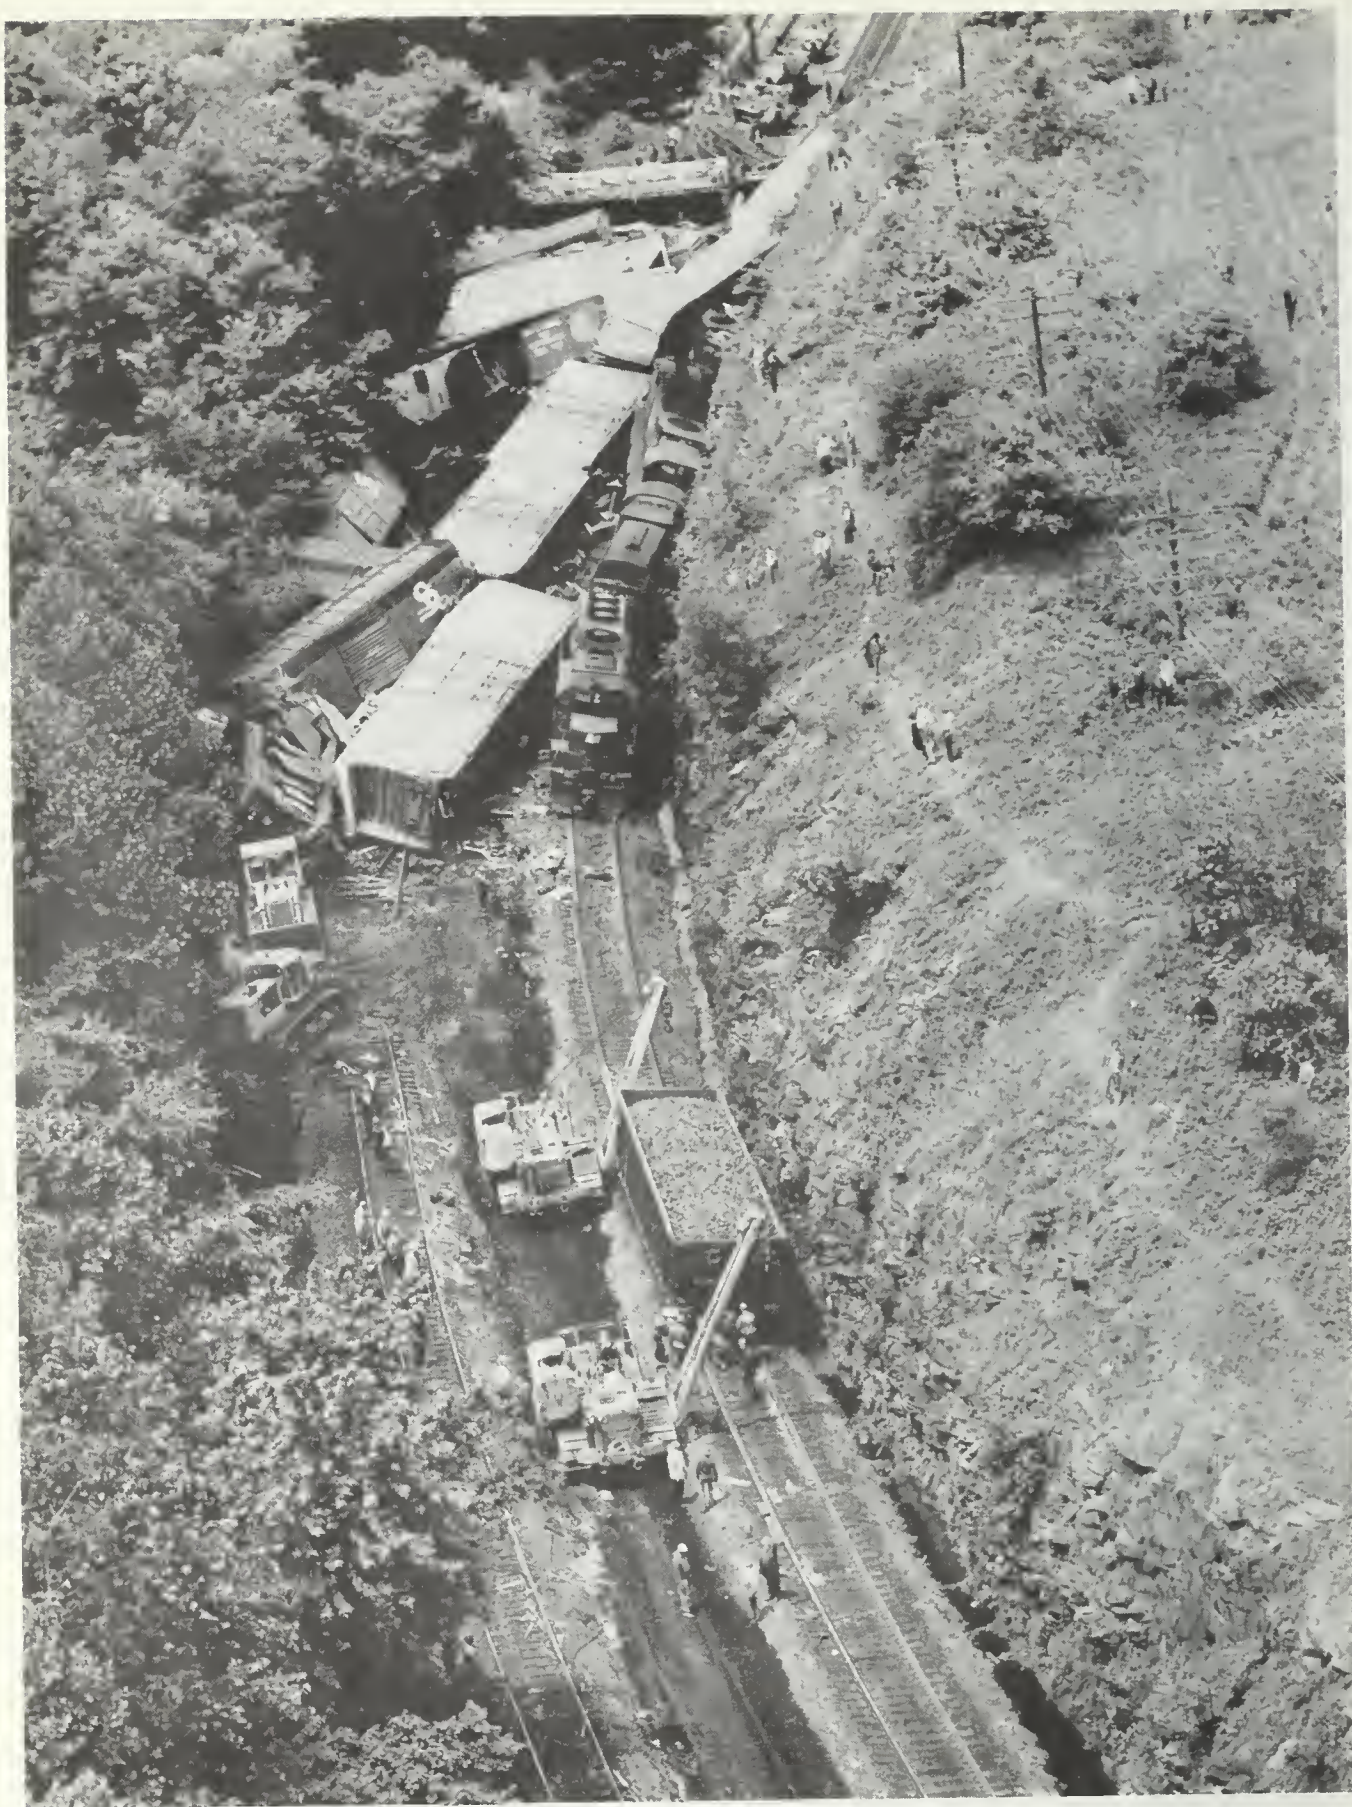
Figure 3. View of the accident site as seen from the east. The point of impact is off the bottom of the photograph.

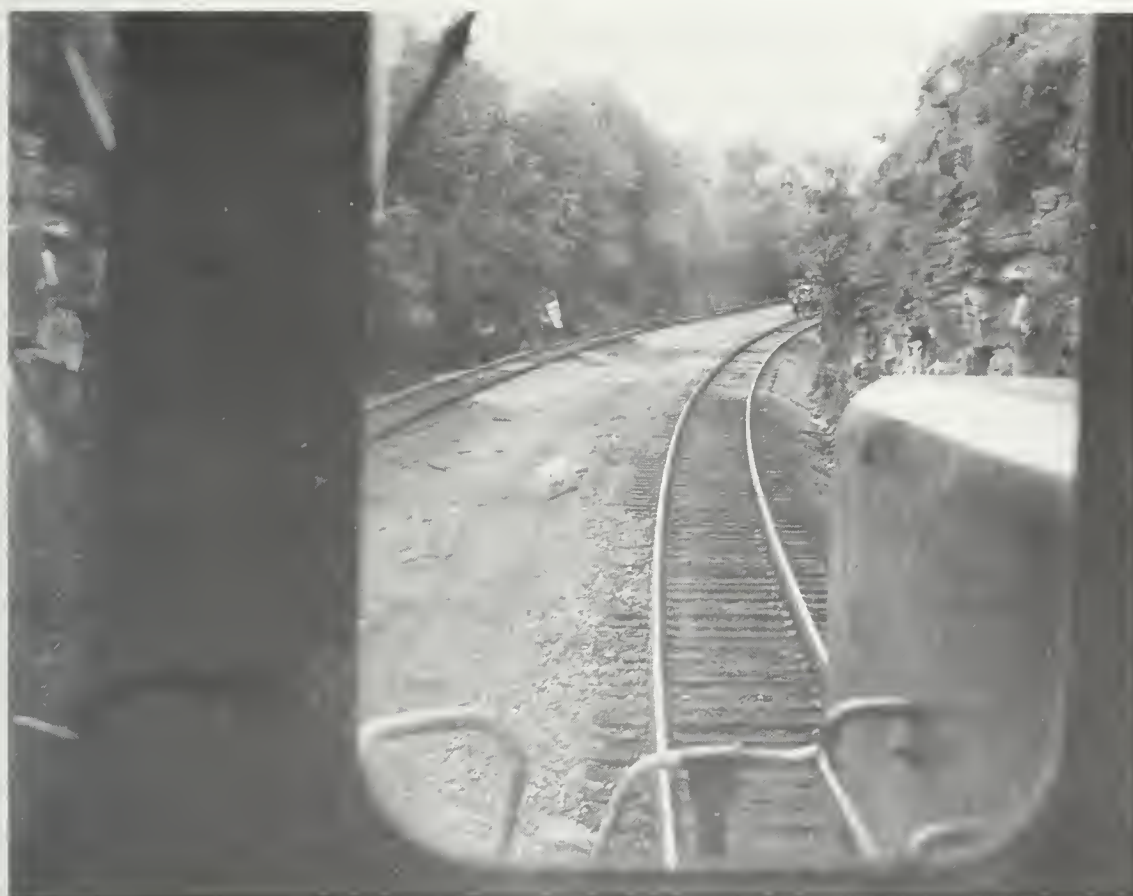
Figure 5. Fireman's view from the approaching locomotive to the point of impact. Men standing in the foreground represent the position of the caboose of Extra 2278 West.

The train used for the stopping tests was similar in consist to Extra 6330 West. The test train consisted of units 6312, 6309, 6341, and 3009, 100 loaded cars, and no empty cars. The tests showed that at 10 mph, Extra 6330 West could have been stopped 59 feet before impact with the caboose. At 17 mph, the test train passed the location of the caboose by 326 feet. These tests indicate that Extra 6330 West was moving faster than the 7 mph estimated by the engineer and brakeman. It was not possible to determine the actual speed of the train.

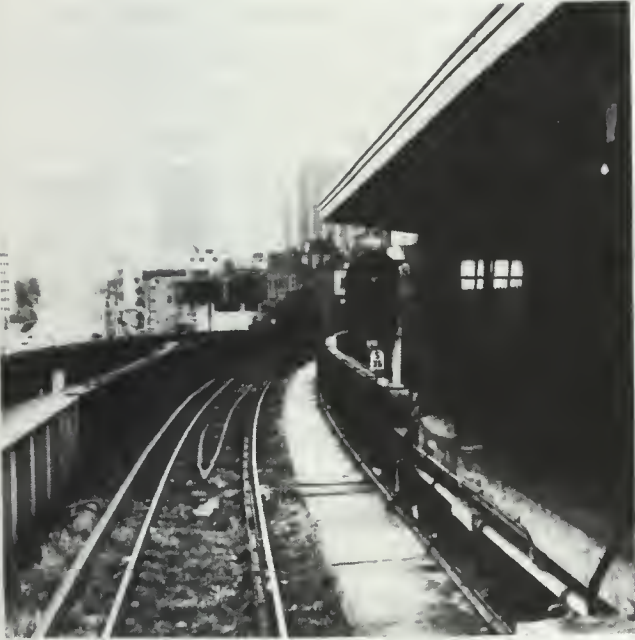
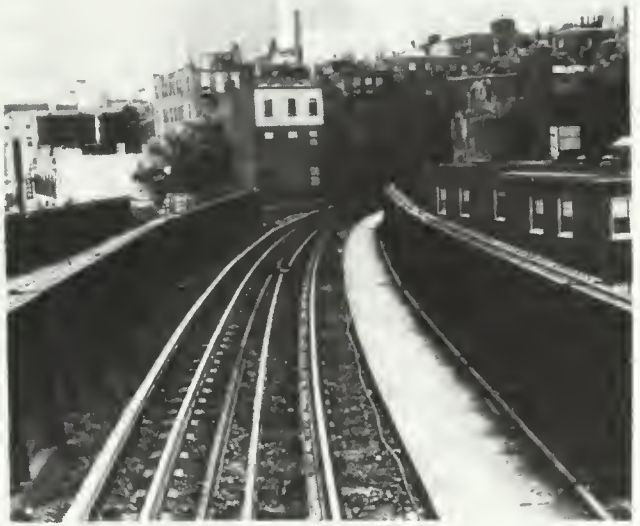
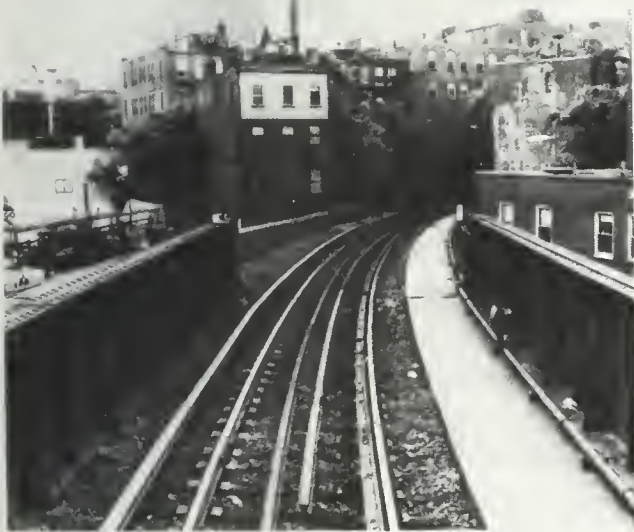
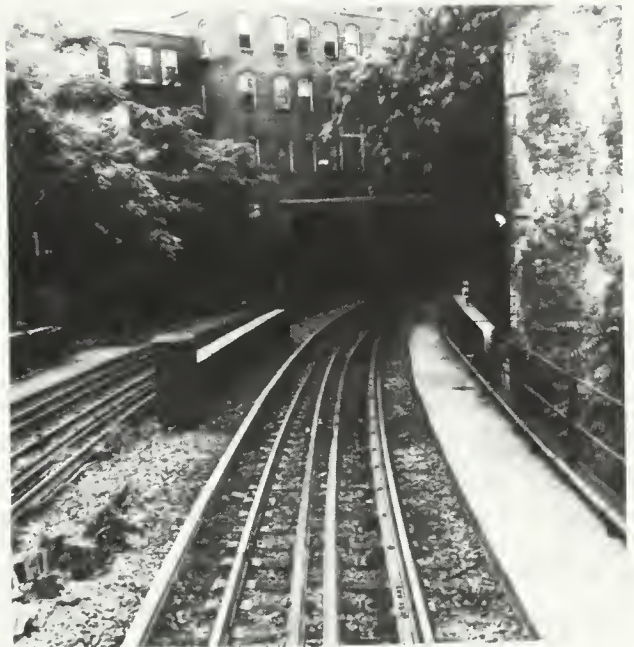
Figure 1. The motormen's views from Charles Street Station to the tunnel

Train 1431, another four-car "Bluebird" train, also was keyed by signal 234 as it left Charles Street Station, and at 5:01 p.m. it collided with the rear of train 1604 about 179 feet inside the subway tunnel. (See Figure 1.)

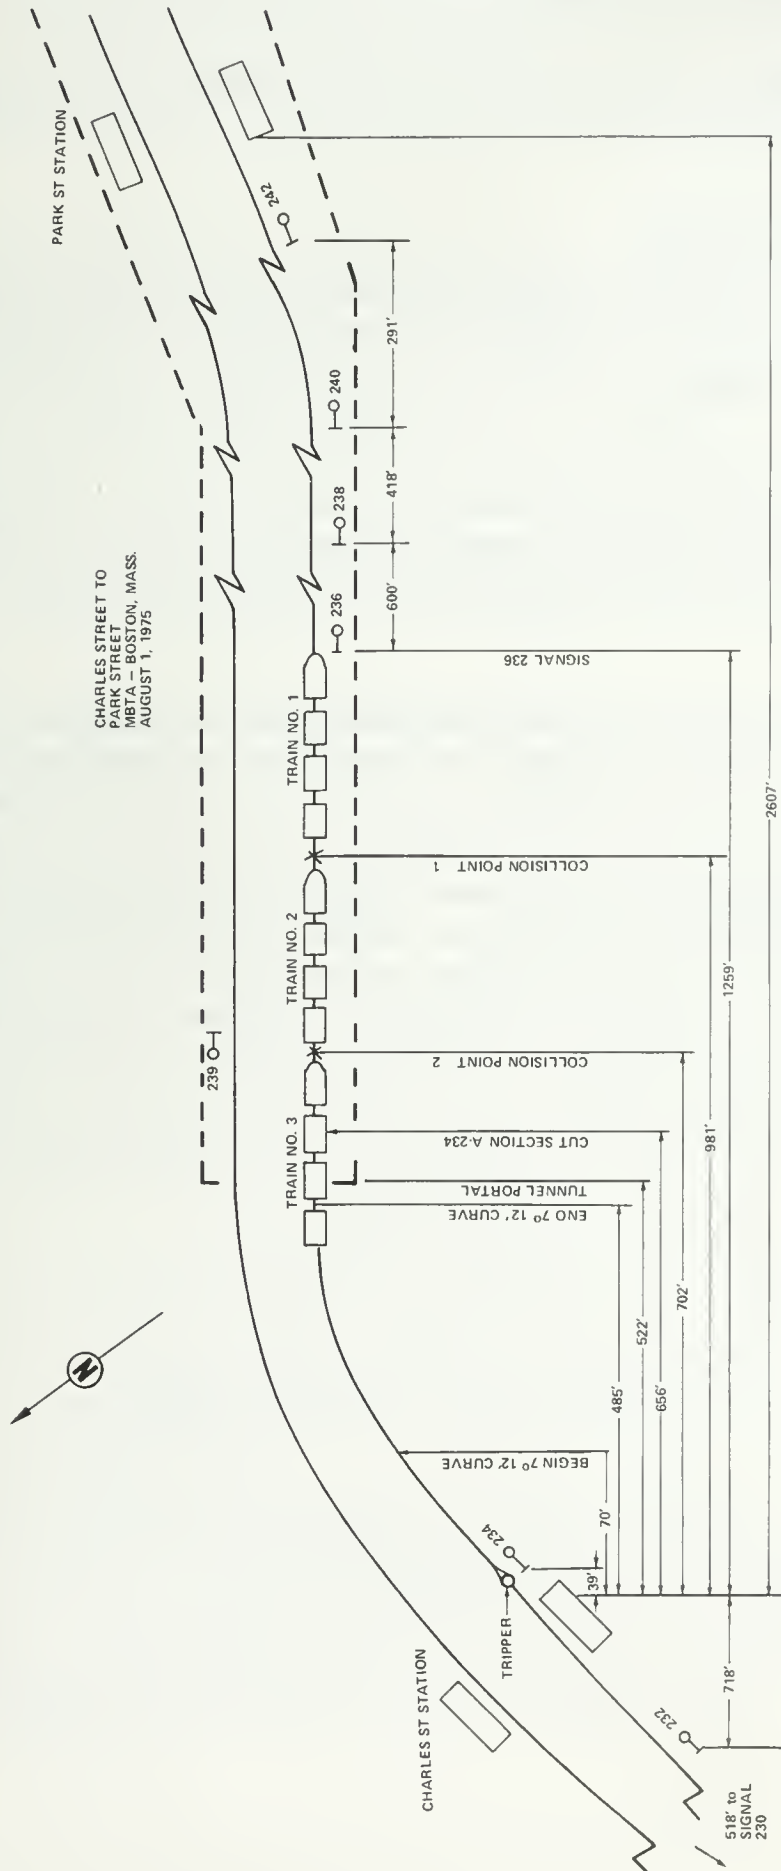
Figure 2. Accident site.

The trains collided on tangent track within a double-track subway tunnel. (See Figure 2.) Southward from the south end of the Charles Street Station platform, it was 39 feet to signal 234, 70 feet to the beginning of the 7° 12' curve, 485 feet to the end of the curve, 522 feet to the portal of the subway tunnel, 702 feet to the point of the second collision, 981 feet to the point of the first collision, 1,259 feet to signal 236, and 2,607 feet to the west edge of the Park Street Station platform. The first collision occurred on a descending 0.50-percent grade; the second collision occurred on a vertical curve which connected a 2.98-percent descending grade to the 0.50-percent grade. Within the subway tunnel there were walkways on the outside of each of the two tracks. The electrified third rails for both tracks were mounted between the tracks. The third rails were not equipped with protective covers. Some of the emergency lighting operated off the 600-volt direct current that supplied power to the third rail and some operated independent of the third-rail power. Fluorescent light

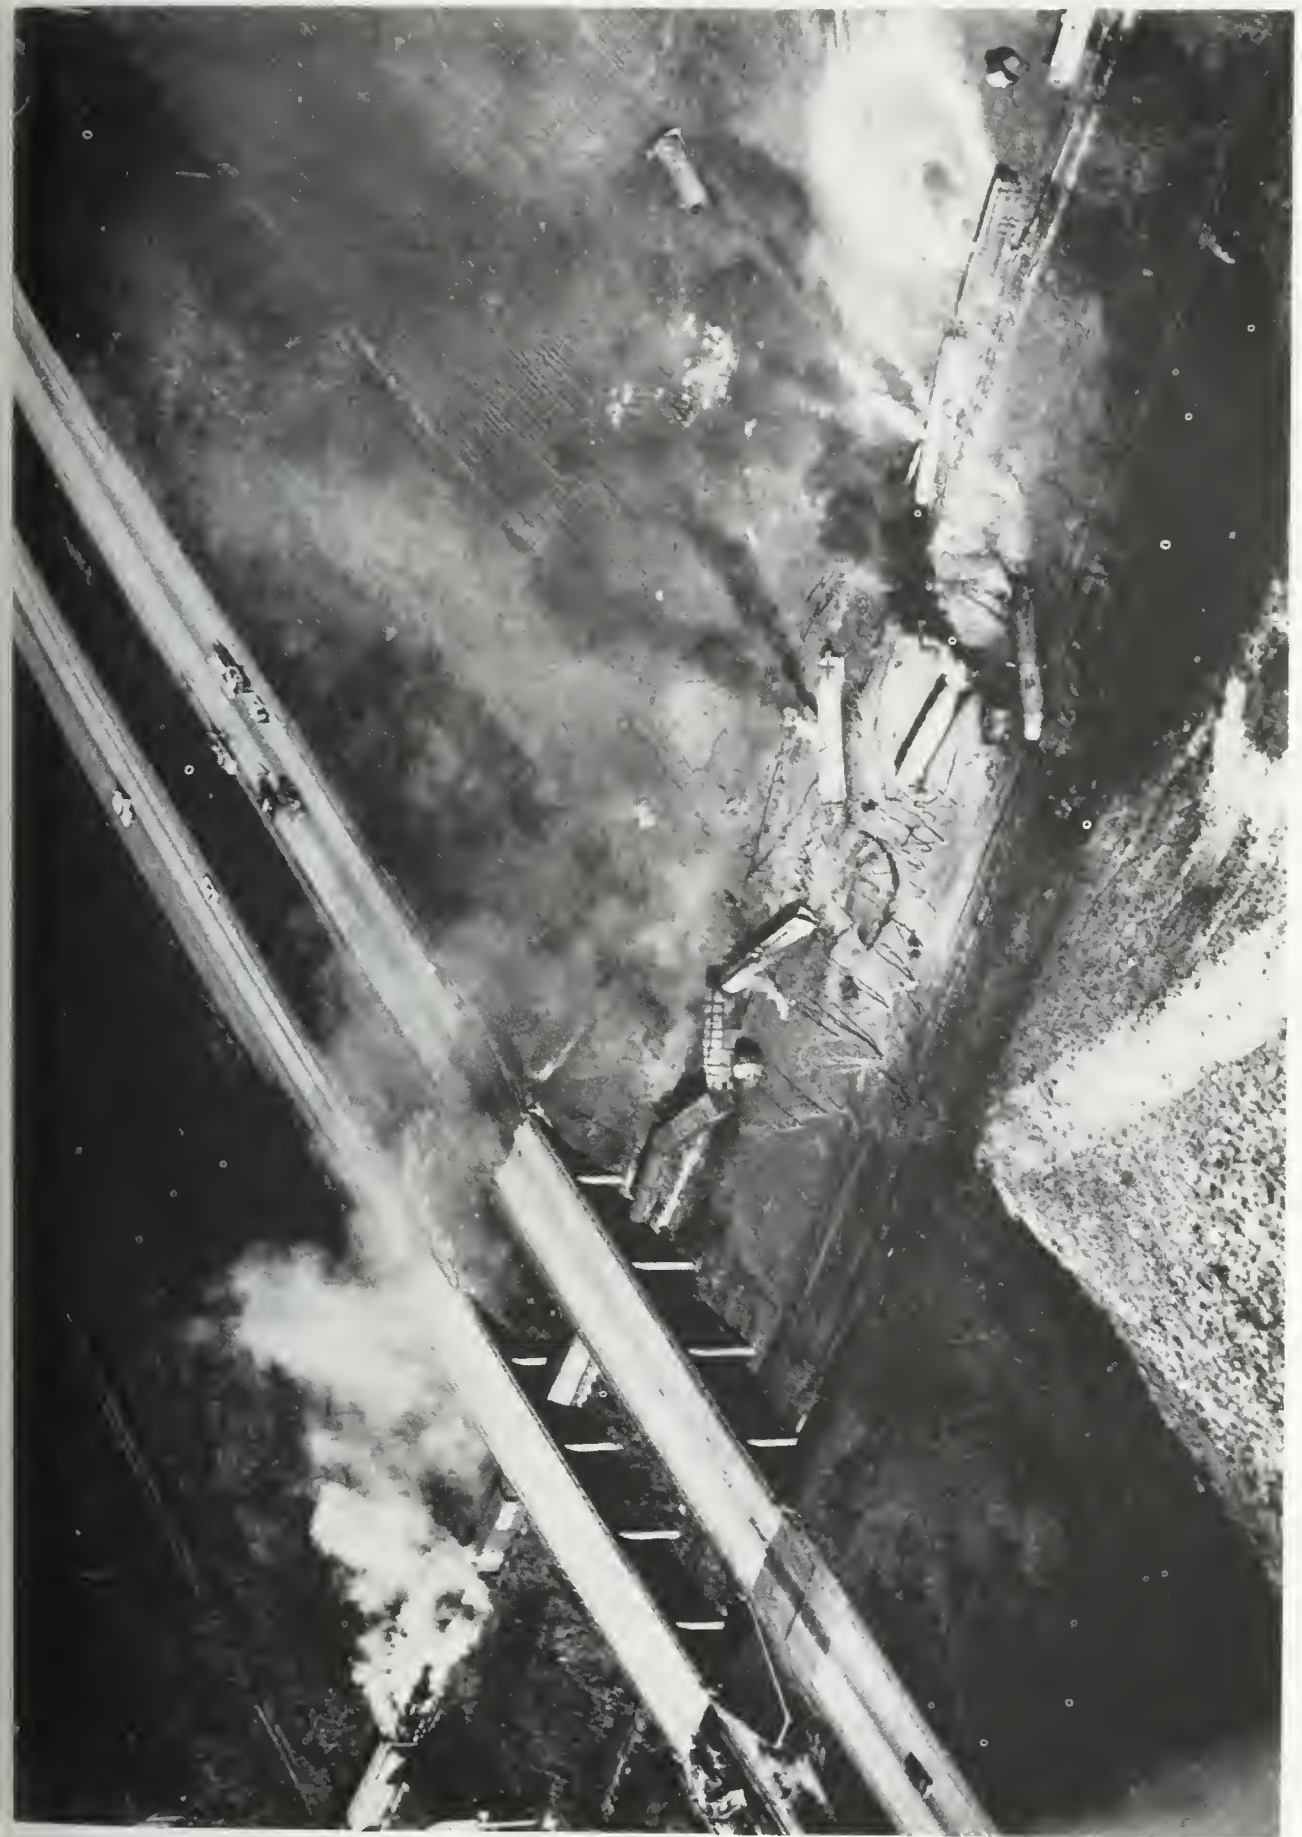
Figure 1. Aerial view of accident site.

The first cars derailed at milepost (M.P.) 77.9 at a No. 10 frog of a left-hand turnout. The major fire and explosions occurred just beyond the highway bridge which carried Interstate Highways 80 and 35 over the railroad. (See Figure 1.) At M.P. 78.6, southbound trains begin to descend 2 miles of a 1-percent grade; the 2 miles extend through the 5,900-foot, 1-degree curve on which the cars derailed.

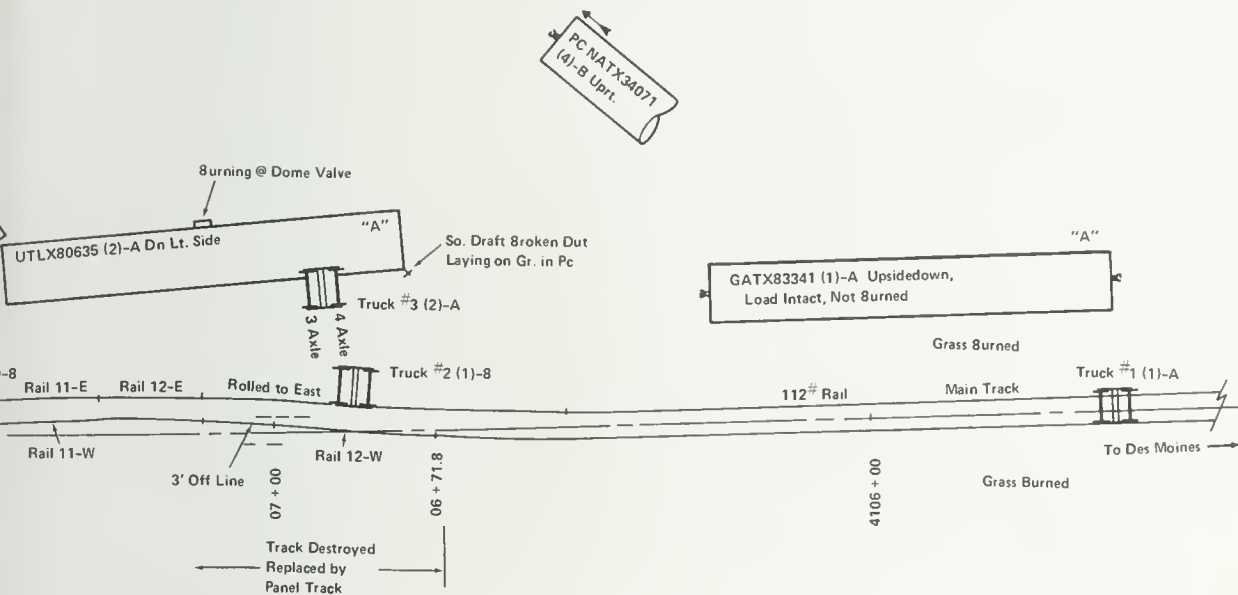
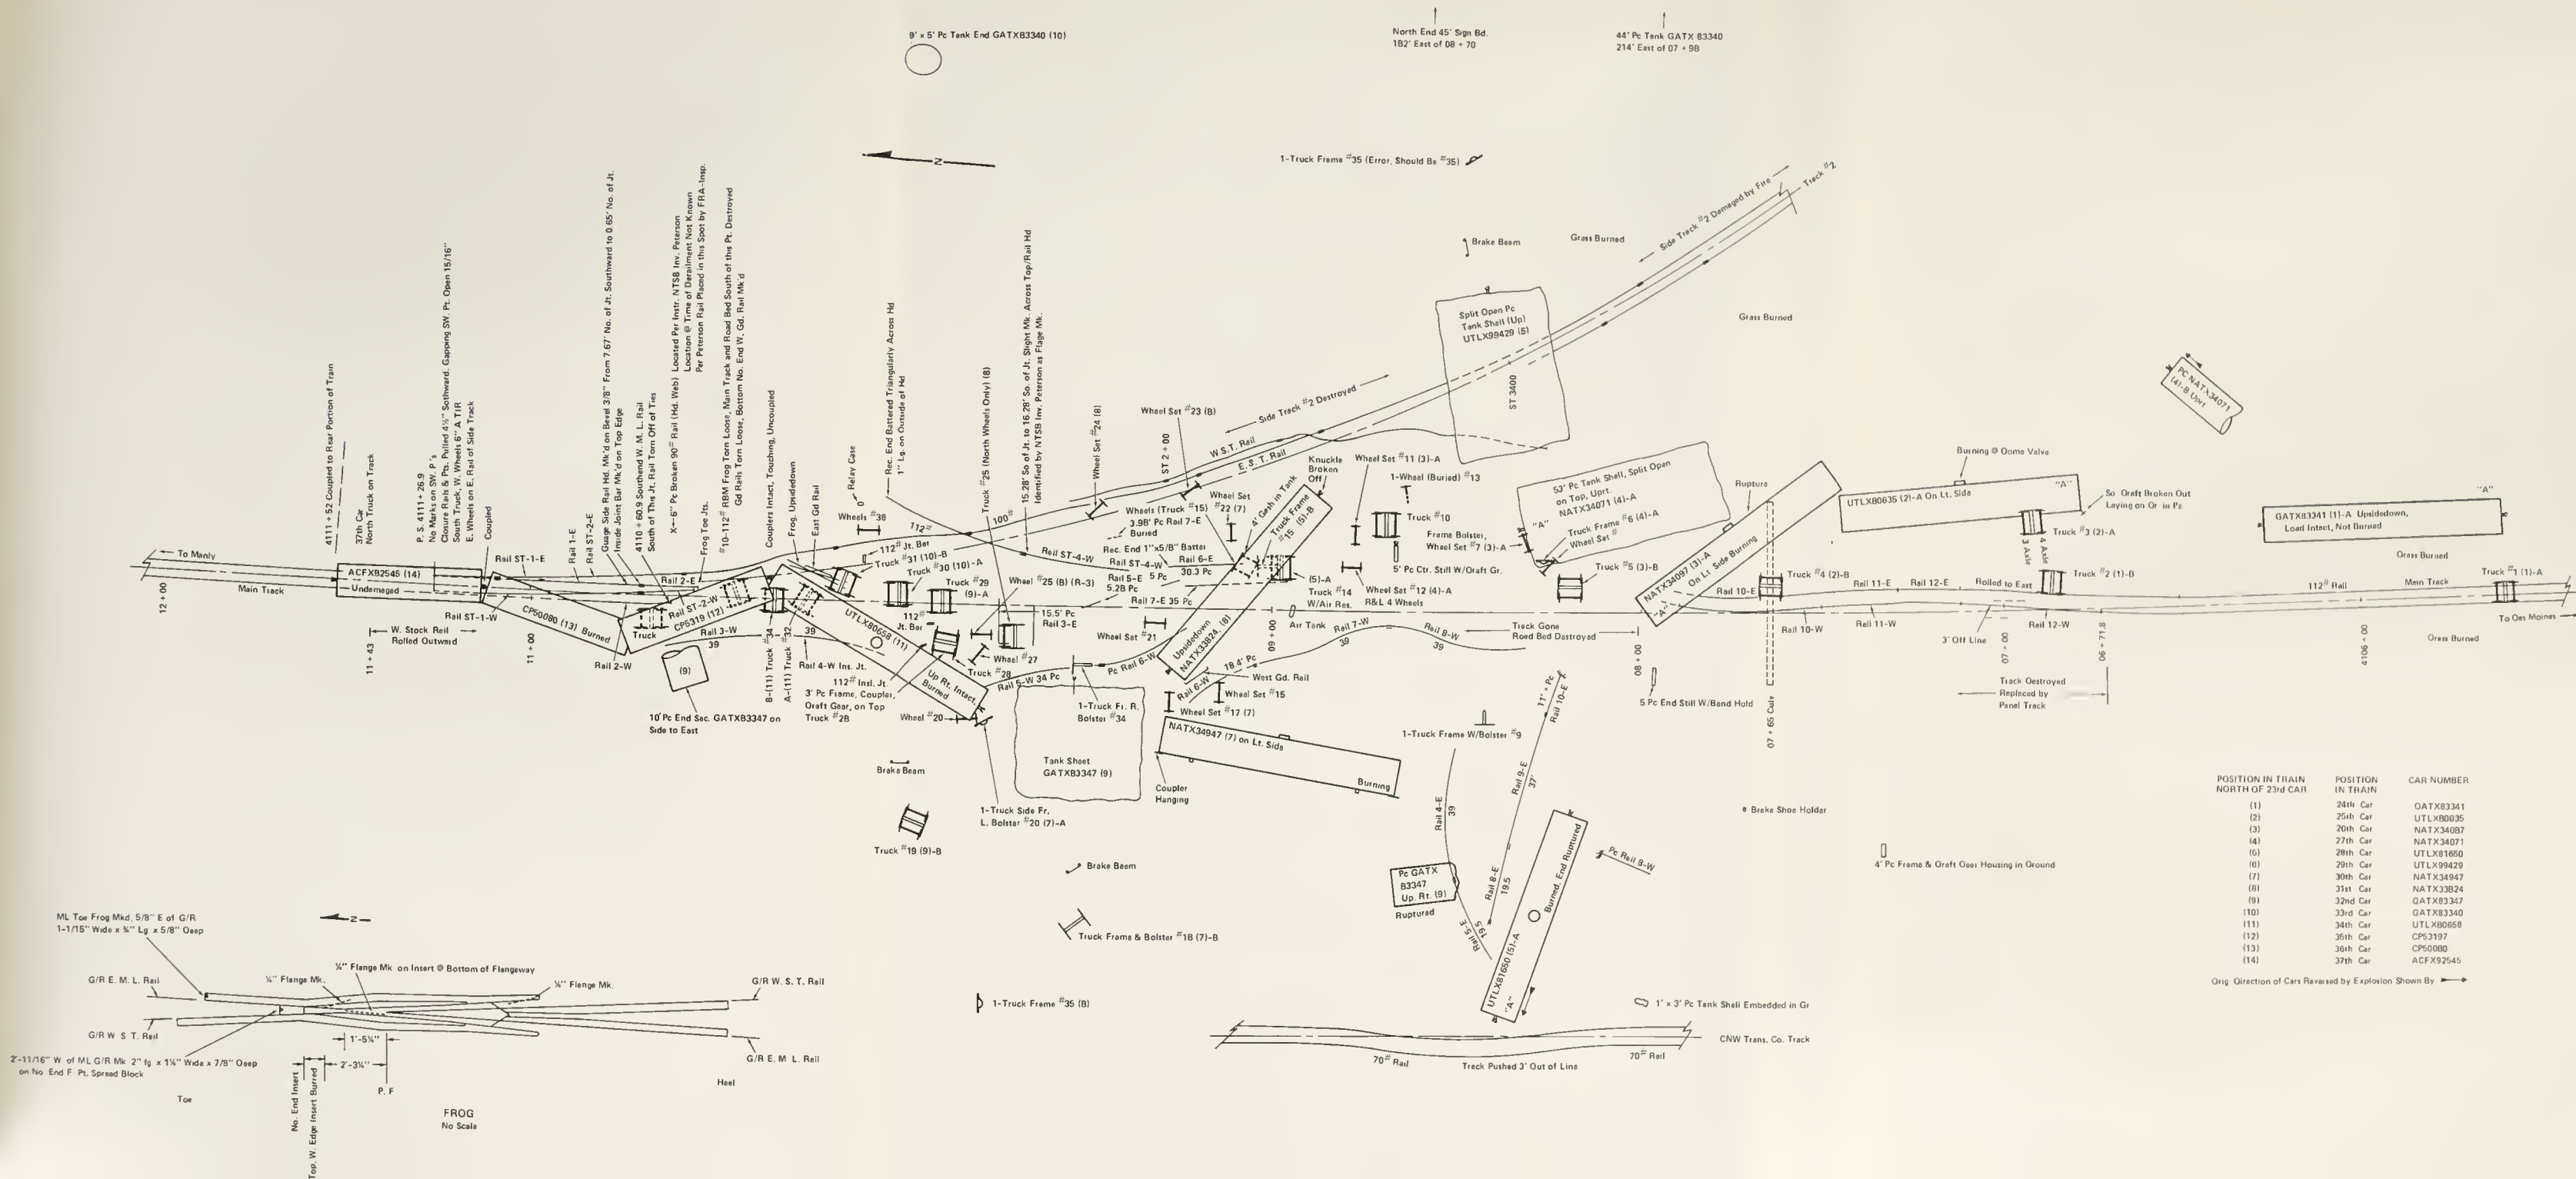
### Figure 2

Dirig. Direction of Cars Reversed by Explosion Shown by ➡

The running gear of the first three cars to derail showed no evidence of mechanical deficiencies. These three cars lost their trucks and appeared to have slid while overturned on their sides. The trailing truck and bolster of the third car were dragged on the track structure before the car overturned. The fourth derailed car exploded and was found in two parts. The lead end of the car consisted of about 1/4 of the car. The head was not punctured. The remainder of the tank shell was flattened by the explosion.
